Manhole Inspection Summary

Manhole # S23KK_064MH

Location Address: **2324 ETING ST**

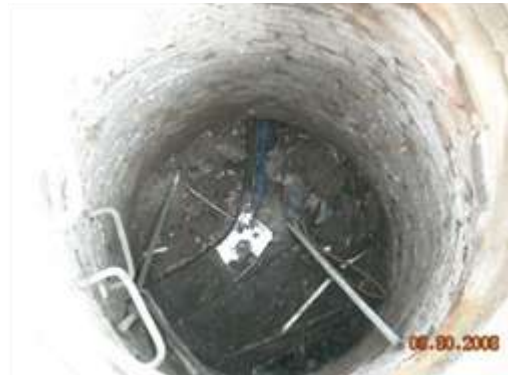
Top View

Corbel and Barrel infiltration. Evidence of surcharge - Bench debris. Channel debris.

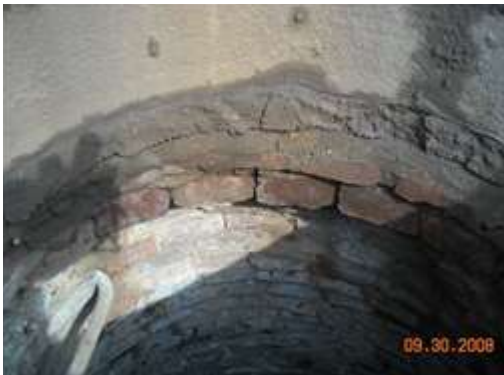
Defect

Frame leaks. Adjustment deterioration and infiltration.

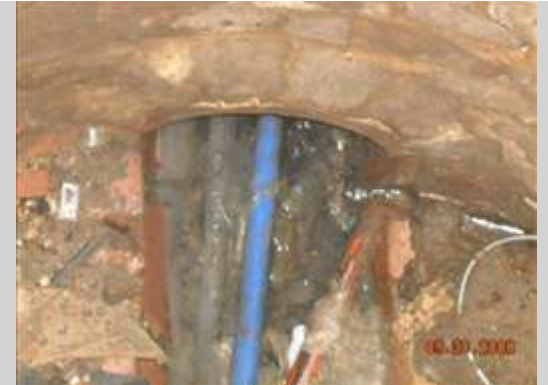
8 in. Circular Gravity Sewer Pipe Out @ 12 O'Clock

Deposits: ☐ None ☒ **Mud** ☐ Sludge ☒ **Debris** ☐ Grease

Silt Depth: **1** (in.) Deposits Extent: **Light**

Infiltration: **Evidence** Pipe Seal Cond: **Unknown**

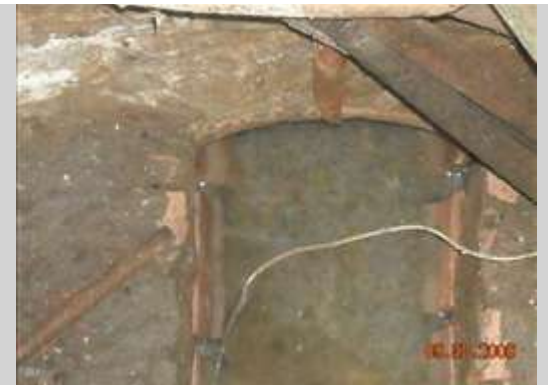
8 in. Circular Gravity Sewer Pipe In @ 8 O'Clock

Deposits: ☐ None ☒ **Mud** ☐ Sludge ☐ Debris ☐ Grease

Silt Depth: **1** (in.) Deposits Extent: **Light**
